## DGNO Railroad

**Kiamichi Rail Road  
Arco Wye  
Connection to AshGrove Cement  
Foreman AR**

**Kiamichi Railroad  
Ashdown Sub Division Main Track  
Near Idabel OK**

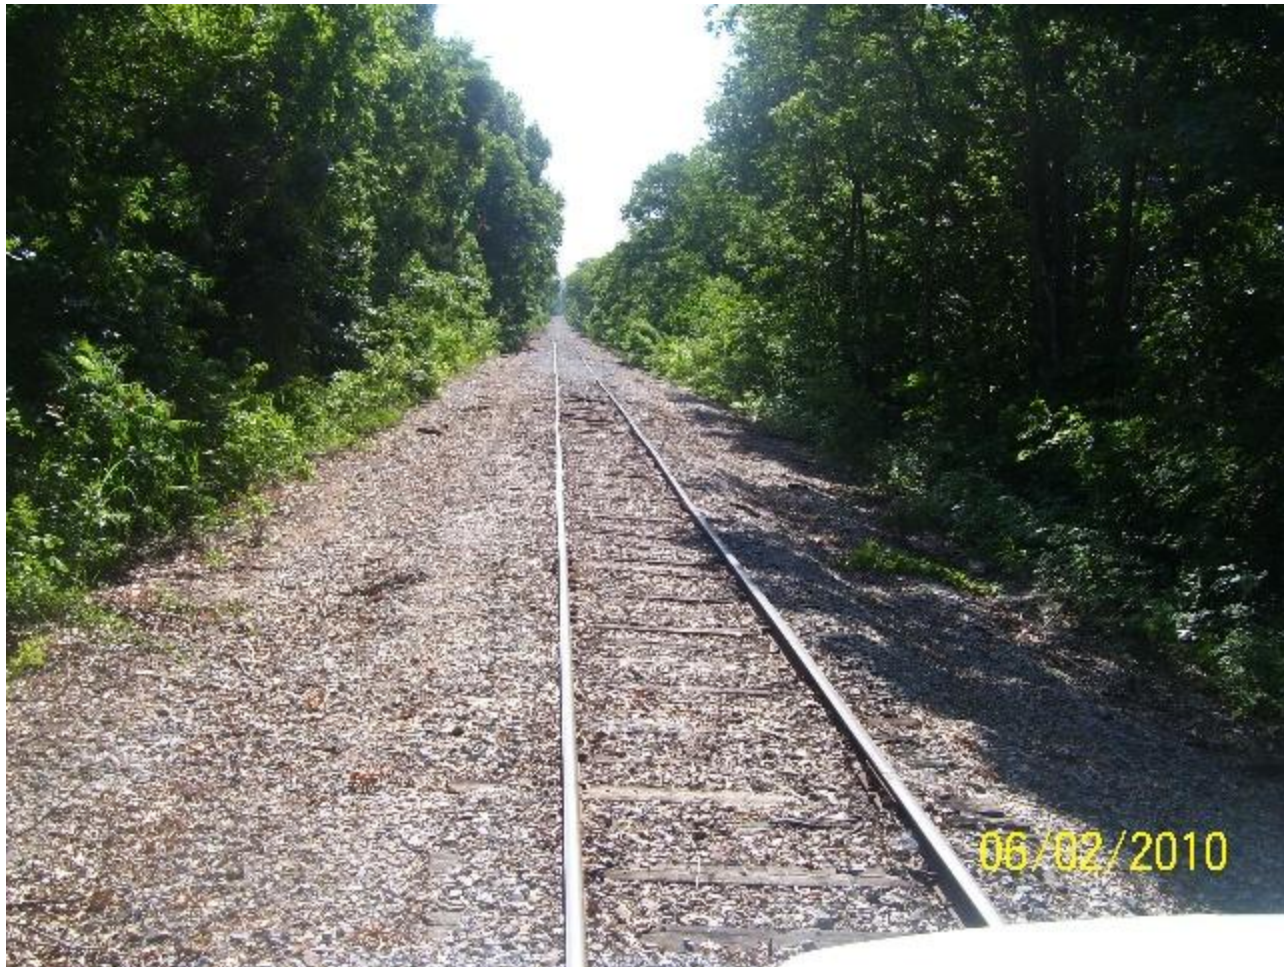
Sherman // McKinney Sub- Division: Typical surface and alignment irregularities  
Limiting operating speeds to FRA Class 1, 10 MPH.

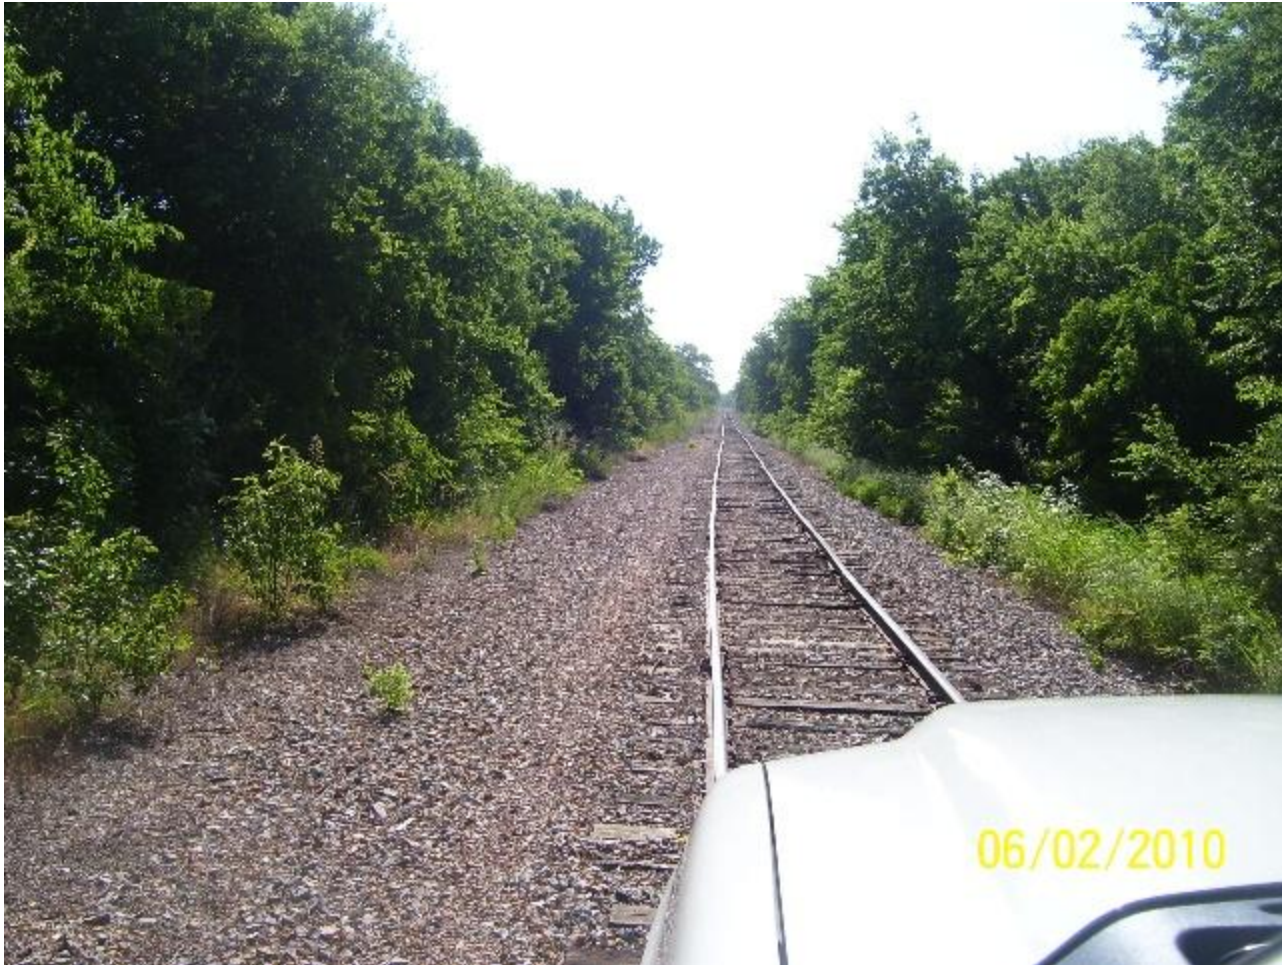
Sherman // McKinney Sub-Divisions: Typical track surface and alignment conditions, limiting train speeds to 10 MPH

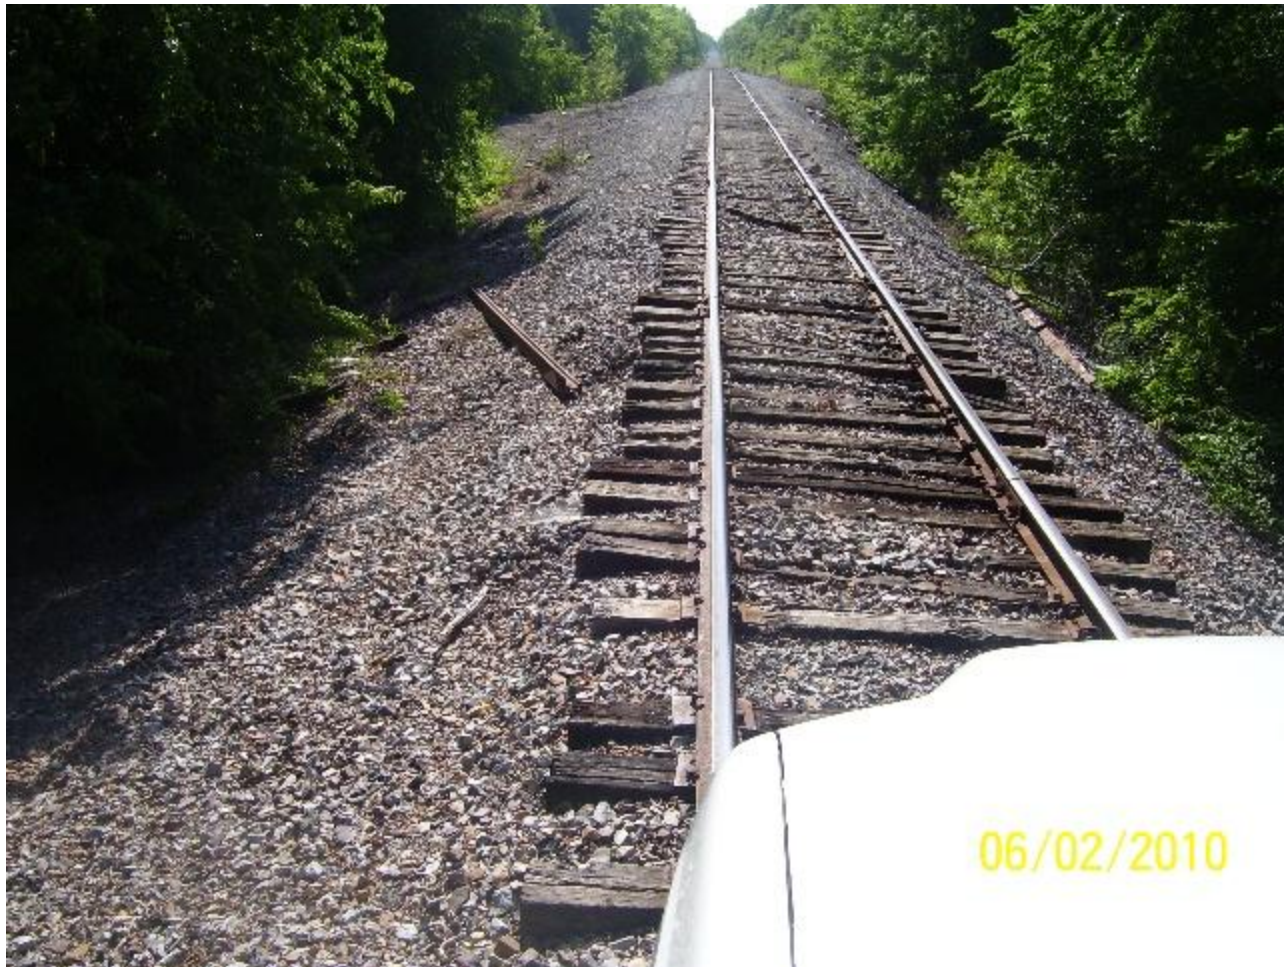
Sherman // McKinney Sub-Divisions: Typical Tie Condition of 800 to 1000 defective crossties per mile.

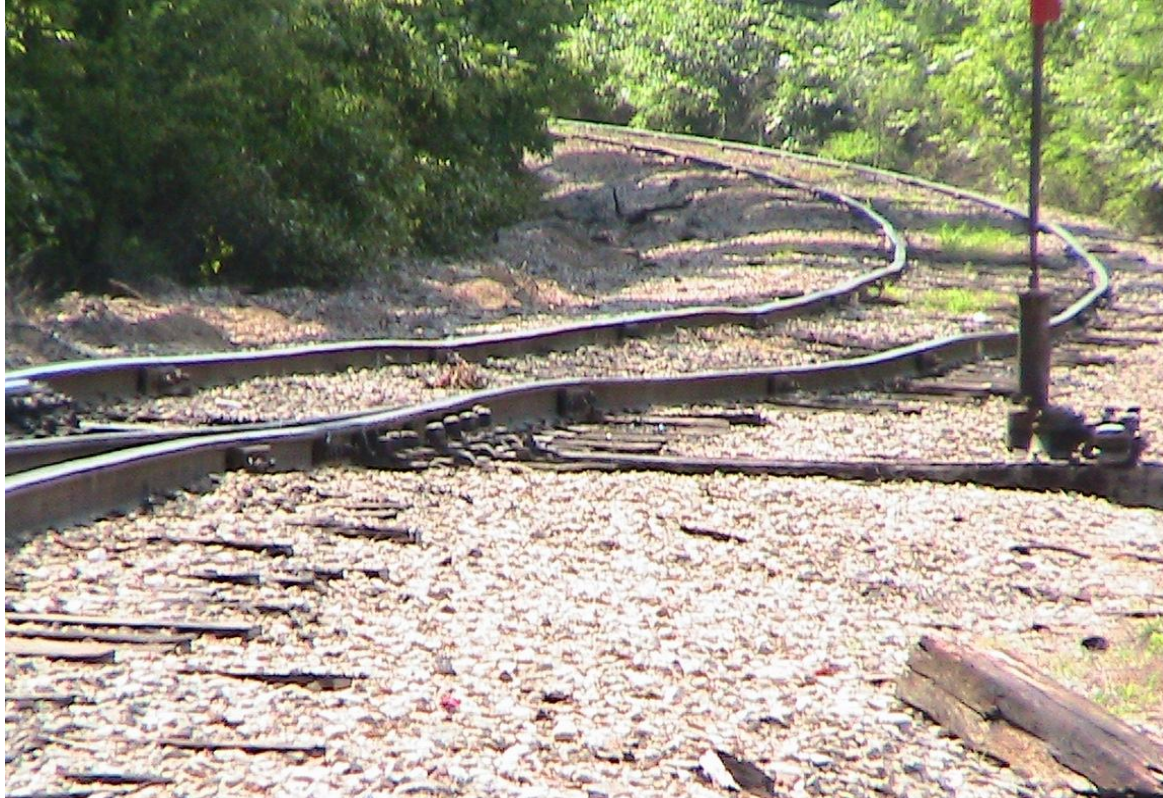
**Track Surface and alignment conditions limiting operation speed to less than 10 MPH**

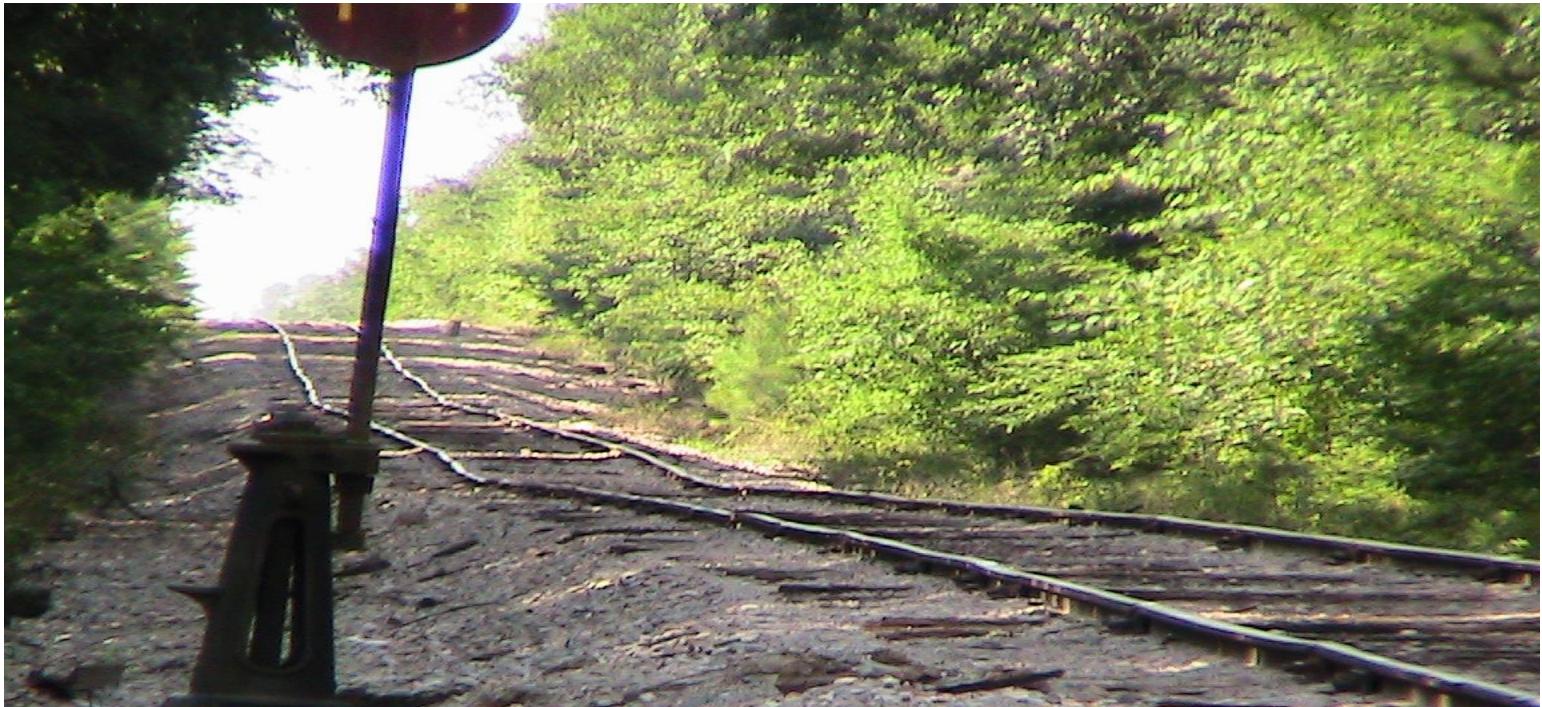
**Kiamichi Railroad  
Arco Lead  
Track connecting Ash Grove Cement to the Main Track  
Foreman AR**

Typical Track Conditions on the Arco Lead

- 75 LB rail – surface bent and worn – non control cooled
- Tie condition, 40% defective (1,200 per mile)
- Track Surface conditions marginal for 10 mph

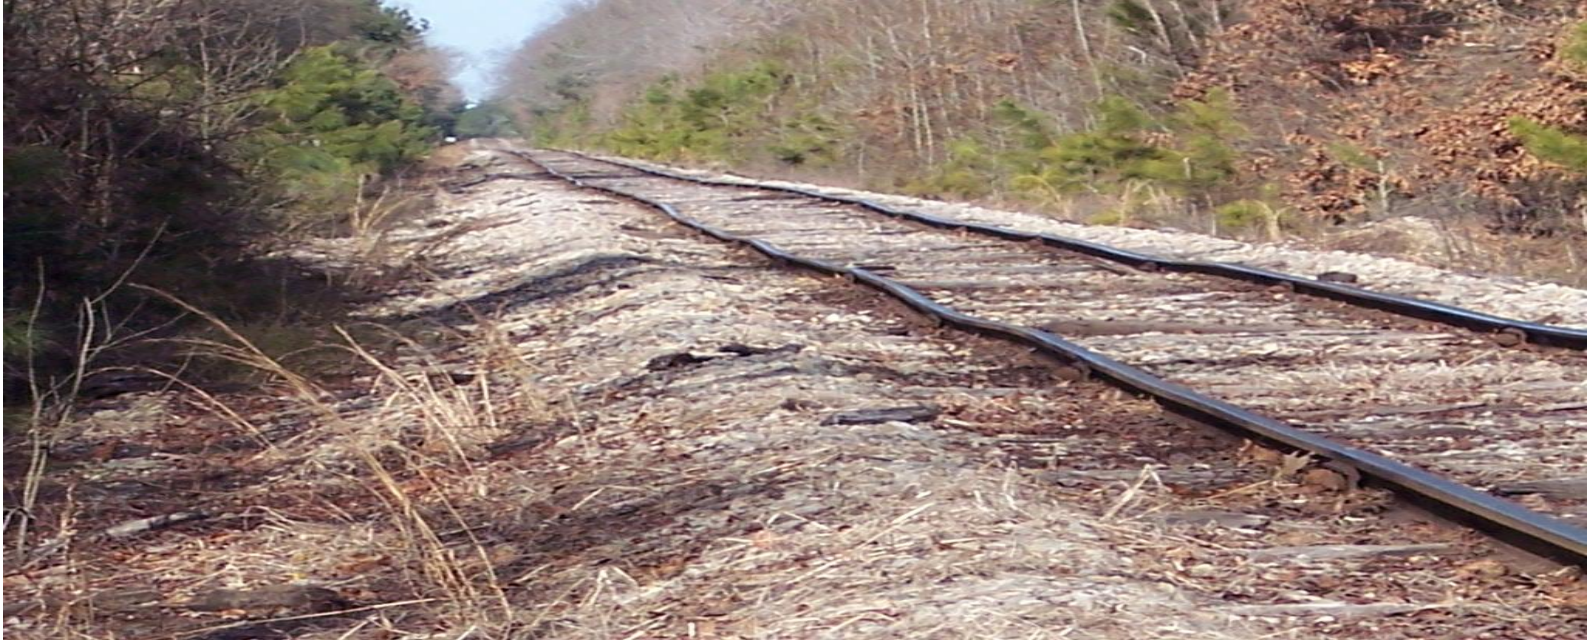
- Typical Track Conditions on the Ashdown Main Track between Ft. Townson, OK and Ashdown, AR
- Tie condition - 30% defective, > 1000 ties per mile
- Track Surface and Alignment – marginal for 10 mph
- Rail - 90/40 section, non control cooled, surface bent with inconsistent rail anchor pattern
